RESEARCH ON ELECTRICAL WIRING USED IN THE CONSTRUCTION OF WORKING MACHINES AND VEHICLES IN THE ASPECT OF FIRE PROTECTION

Keywords: construction of working machines, electrical wiring, fire protection

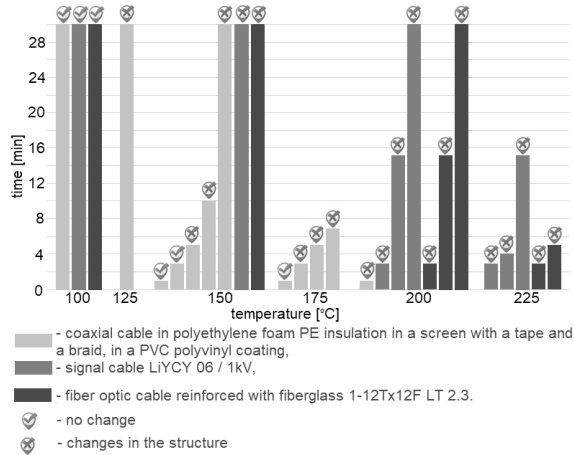
Fig. 3. The resistance level of the tested wires to high temperature until the condition of the coating changes

The resistance level of the tested wires to high temperature is presented until the condition of the coating changes in Figure 3, and until the changes allow for shorting the metal elements of the wire in Figure 4.

All tested wires are resistant to temperatures up to 100°C during convection with a steel plate in less than 30 minutes. Increasing the temperature causes plastification of the non-metallic layers of the wire. The temperature, and in particular the time of its impact on the test sample is the reason for the occurrence of plasti-
